Porsche 968 Variocam Assembly: Inspection Procedure and Maintenance Schedule

Issue 1 April 2003.

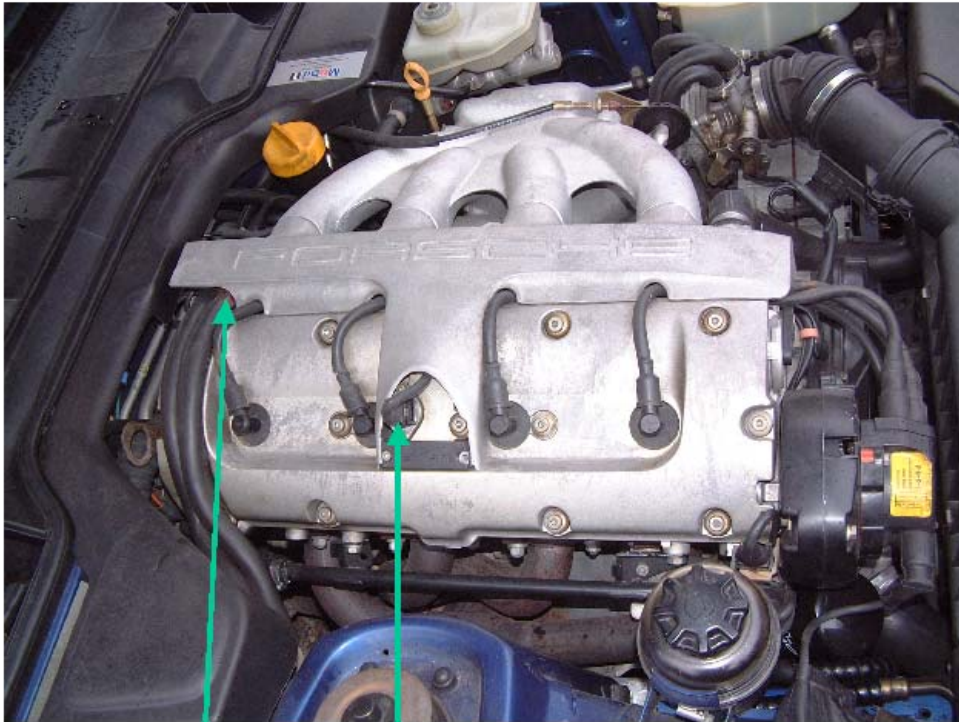
Figure 1

Fuel hose connectors

Variocam electrical connector

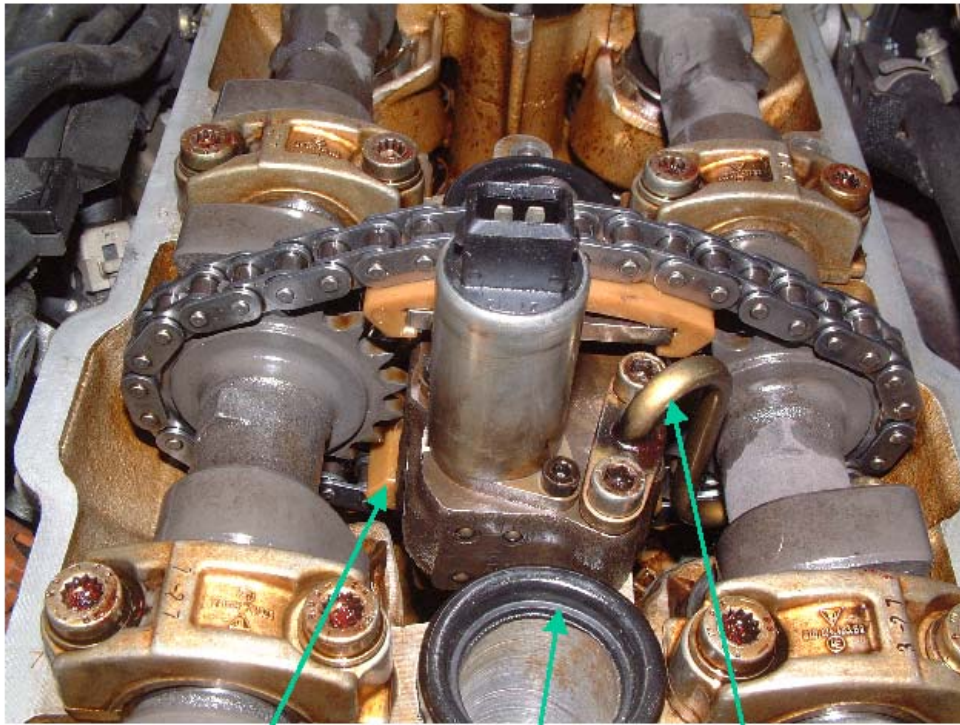
Figure 2

Lower Tensioner Pad

Oil Feed Pipe

Spark plug recess sealing ring

Variocam Assembly Viewed From Rear
(new cams, chain, tensioner pads)

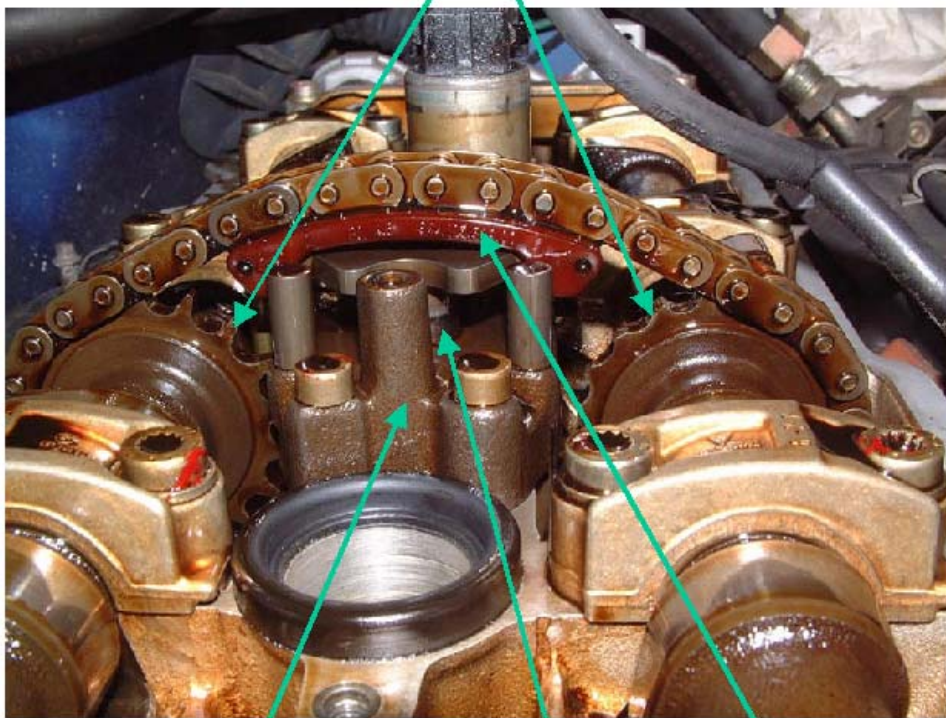
Figure 3

The effects of a stretched chain, are easily visible on **sprocket wear patterns**. Figure 5 shows a used but “serviceable” camshaft, while Fig. 3 shows a badly damaged

camshaft. Even if there are few or no missing teeth, a cam has to be changed when the central teeth part is too thin, hence prone to break. Compare teeth profile of fig. 3 (bad) with that of fig. 6 (new), and you have a good idea of how to judge your cam.

Camshaft sprockets
(note missing teeth on intake cam)

Variocam Tensioner Assembly

Top tensioner pad

Tensioner piston

Damaged cams, 144,000 kms (89,000 miles)

21. Rotate the crankshaft sufficiently to turn the camshafts so that previously hidden teeth on the sprockets can be inspected. Continue until all teeth have been properly inspected (requires two complete crankshaft revolutions). Any missing or badly damaged teeth will require camshaft replacement (see figure 3).

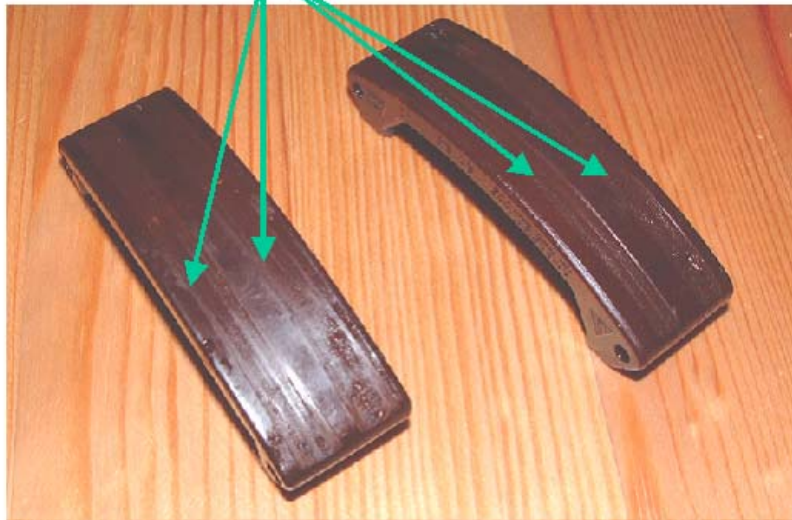
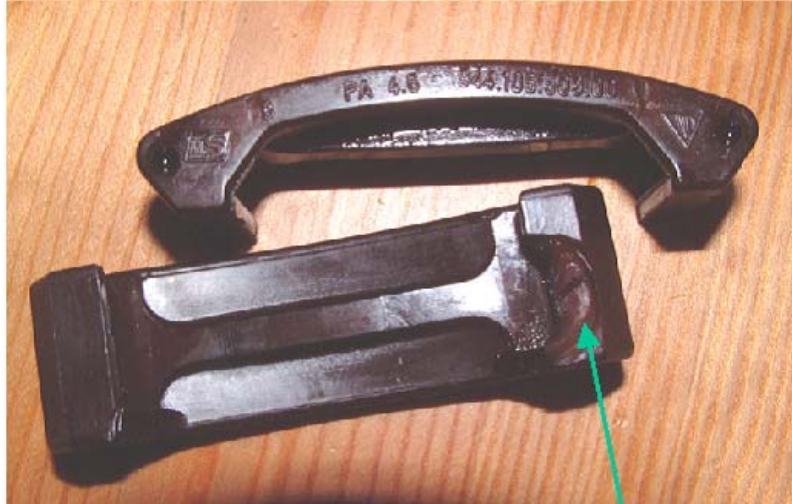
Figure 4

- Dark brown color of pads (new ones are light brown). This is not a definitive criterion, but comparing fig. 4, 5, 6 you can see that the darker pad is the worst one;
- Small “craters” visible in the wear grooves. These craters means the nylon is brittle, and small chunks of material are thrown away in stress conditions. In normal wear, the grooves have an “even” surface. If you have rough surfaces, clearly visible in Figure 4, immediately change both pads.

Wear Grooves

Broken Section

Old Tensioner Pads

To avoid major problems, change pads every 8 years, even if the “wear limits” are apparently not yet reached.

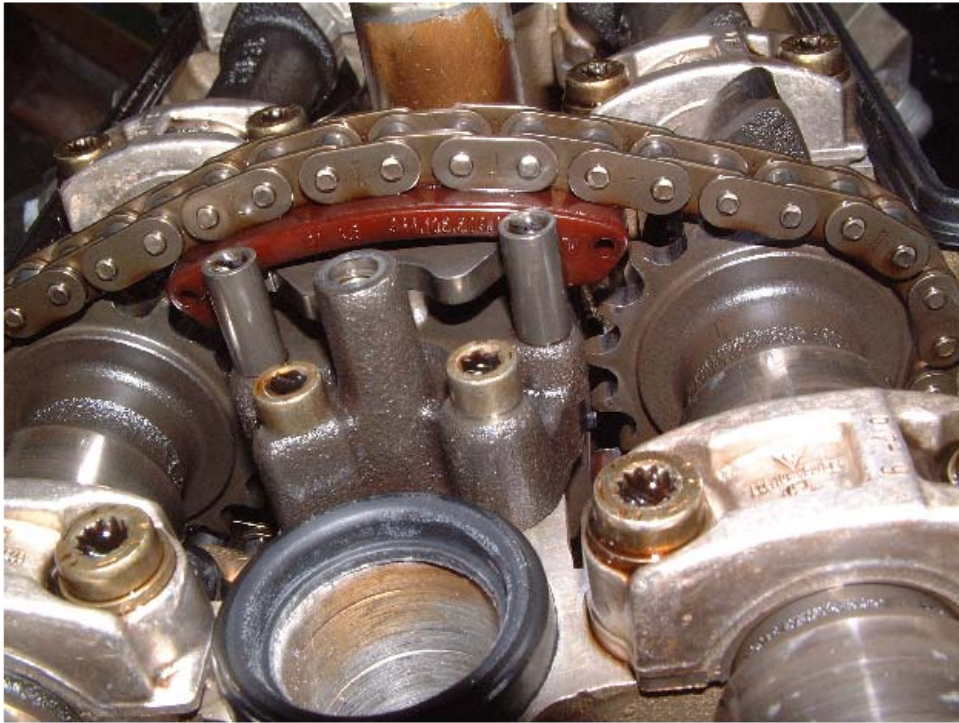
Figure 5

Serviceable Cams, 130,000 km car

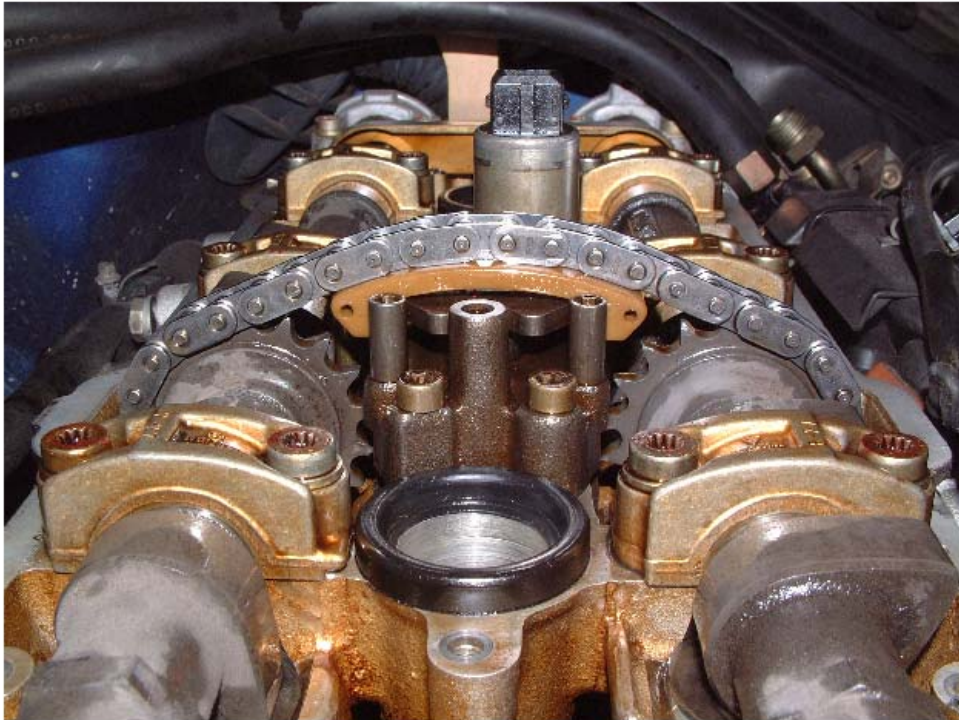
Figure 6

Brand New Cams, Chain, Tensioner Pads
